# Zimbabwe

## Quantifying destruction - satellite images of forced evictions

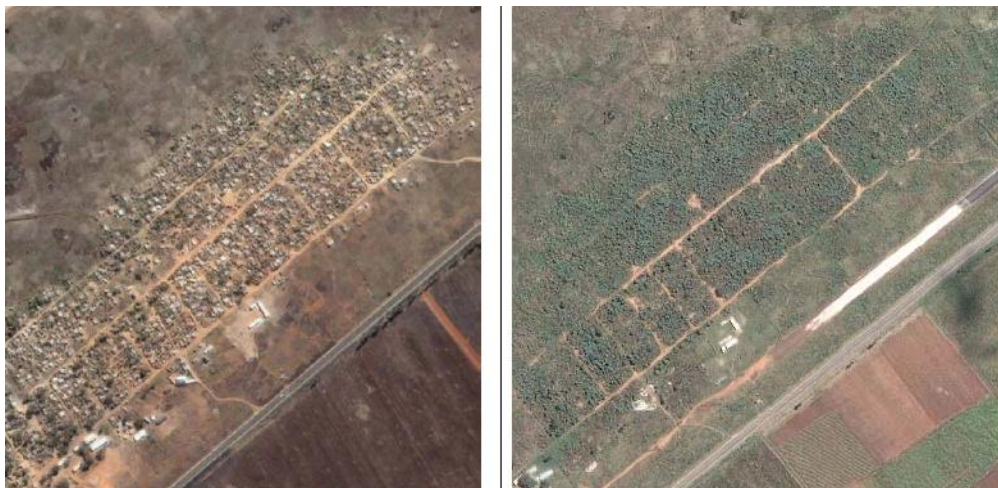
**Figure 1: Porta Farm Before and After Operation Murambatsvina**

High resolution satellite imagery of the Porta Farm settlement in Zimbabwe. More than 850 structures are visible in the before (left hand) image, practically all of which are absent from the after (right hand) image. Note that the significant difference in colour between the images is due to seasonality as the before image was captured during the dry season while the after image was acquired during the rainy season. Images (C) COPYRIGHT 2006 DigitalGlobe, Inc. ALL RIGHTS RESERVED.

Two QuickBird satellite images were obtained covering the area of Porta Farm, including a “before” image from 22 June, 2002 and an “after” image from 6 April 2006 (see Figure 1).<sup>6</sup> The satellite images clearly show Porta Farm in 2002 as a vibrant settlement while only some of its roads and vegetation remain in 2006.

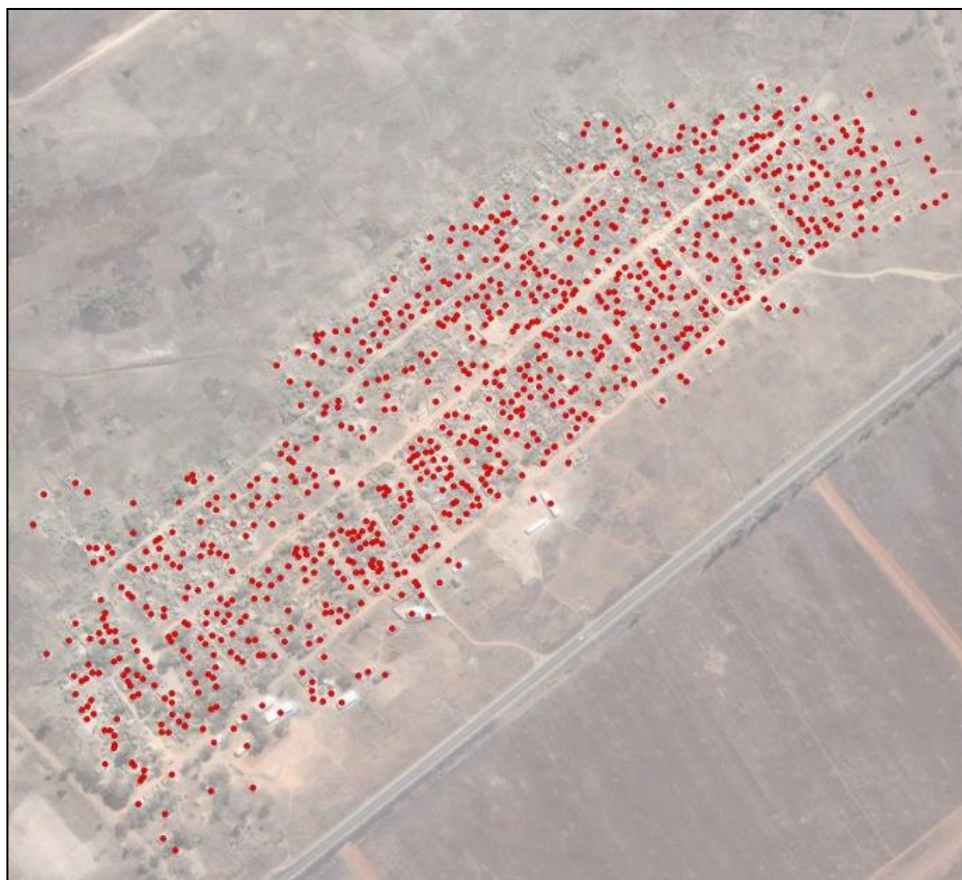
**Figure 2: Porta Farm Structure Count**

The Porta Farm settlement with centre points of destroyed structures.  
Images (C) COPYRIGHT 2006 DigitalGlobe, Inc. ALL RIGHTS RESERVED

Visual analysis of the 2002 image was undertaken to determine the approximate number of structures removed during the interim period. Specifically, the 2002 image was loaded in ArcView GIS and individual visible structures were counted (see Figure 2). A total of 870 structures were counted. The majority are absent from the “after” image. Based on image analysis, more than 850 structures were apparently removed during Operation Murambatsvina.

The dimensions of the settlements and its structures were also measured, indicating a long axis of 1017 meters and a short axis of 257 metres for Porta Farm. The size of the structures themselves varied quite widely, with small structures measuring four meters on a side and larger structures measuring up to 40 square meters and more.

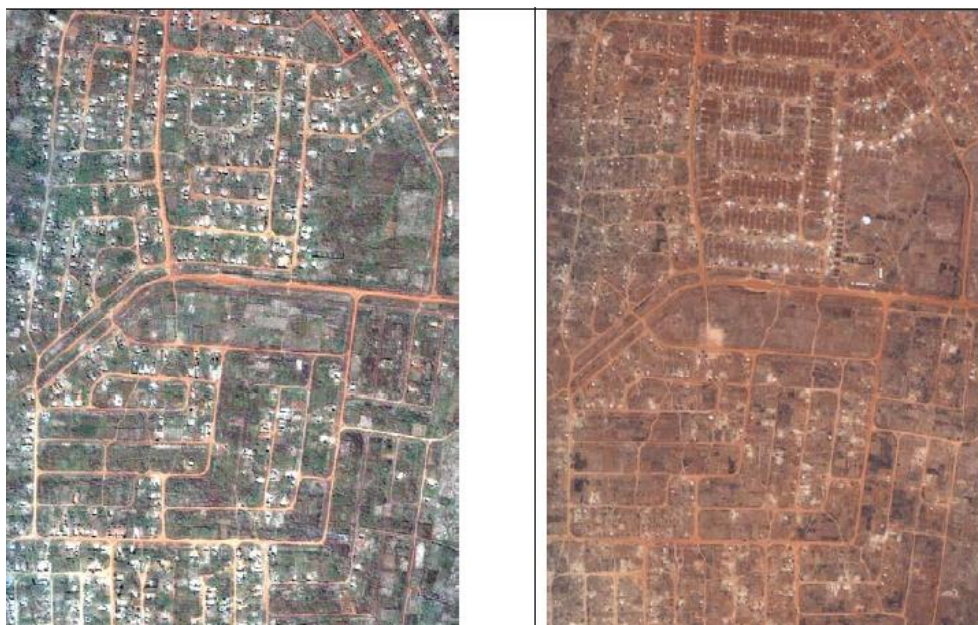
**Figure 3: Hatcliffe Extension New Stands Before and After Operation Murambatsvina**  
High resolution satellite imagery of the Hatcliffe Extension New Stands settlement in Zimbabwe. More than 700 structures are visible in the before (left hand) image, most of which are absent from the after (right hand) image. Note that the significant difference in colour between the images is due to seasonality as the before image was captured during the dry season while the after image was acquired during the rainy season.

Four QuickBird images were obtained.<sup>7</sup> The first set of images (Figure 3) shows a “before” image from 14 May 2004 and an “after” image from 2 September 2005 of the area of Hatcliffe Extension known as Hatcliffe Extension New Stands. The satellite imagery clearly shows the settlement in 2004 while the 2005 image shows most homes removed.

As before, the images were analysed to determine the approximate number of structures destroyed. This analysis revealed a total of 764 structures visible in the “before” image of Hatcliffe Extension New Stands and 875 structures visible in the “before” image of Hatcliffe Extension Holding Camp, which were absent from the “after” images. In addition, an undetermined number of backyard structures were also possibly removed from the nearby formal suburb of Hatcliffe.

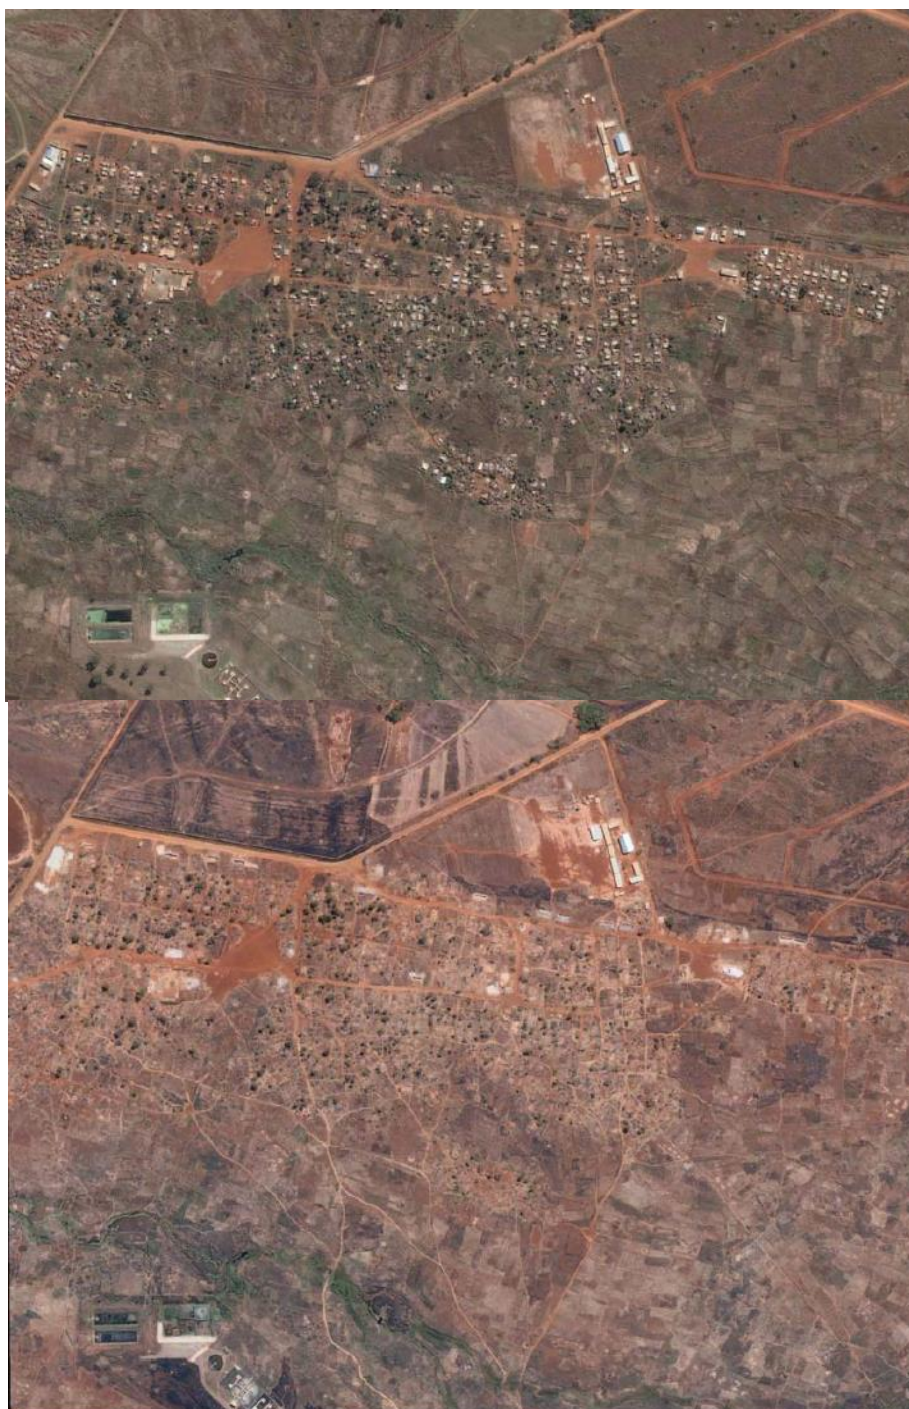
**Figures 6 and 7: Hatcliffe Extension Holding Camp Before and After Operation Murambatsvina**  
These images show a “before” image from 14 May 2004 and an “after” image from 2 September 2005 of Hatcliffe Extension Holding Camp.

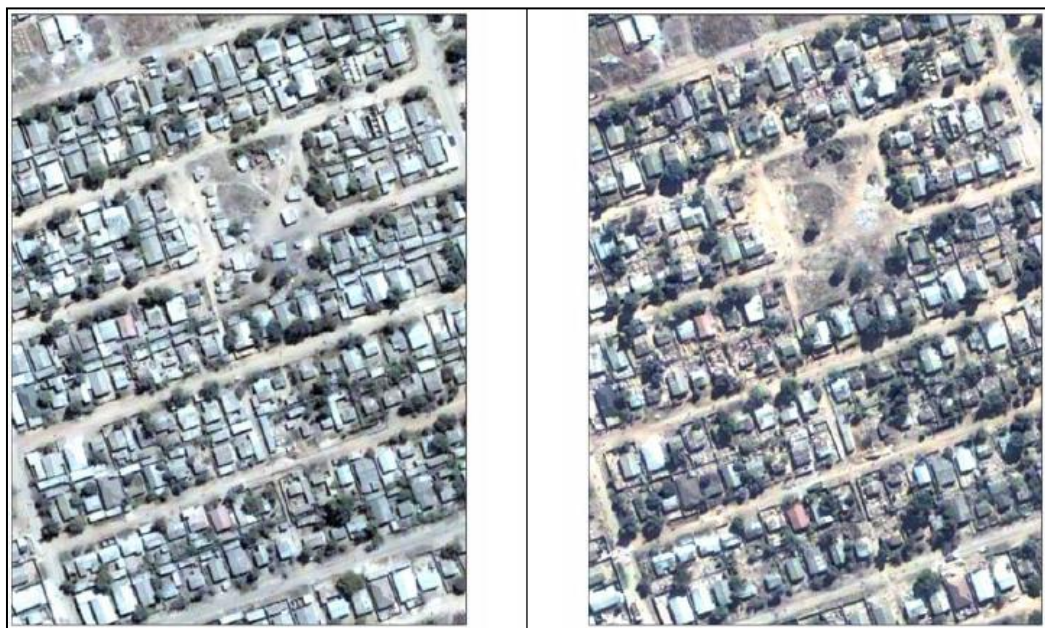
**Figure 9: Chitungwiza Before and After Operation Murambatsvina**

A subset of the high-resolution satellite imagery of Chitungwiza town in Zimbabwe. Backyard homes are visible in the left-hand (before) image and are the smaller structures found on the periphery and in the alleys of larger structures, which are absent from the right-hand (after) image. In addition, what appears to be a marketplace seen in the “before” image is absent from the after image.

Analysis of the images indicates widespread demolition of backyard homes. Backyard homes were essentially built on small patches of land leased to renters by owners of larger, permitted structures (see Figure 9). Amnesty International researchers visited the St. Mary’s area in August 2005, at which time the evidence of the demolitions was widespread. Almost every house in St. Mary’s was surrounded by the brick rubble of destroyed backyard structures. Foundation slabs were clearly visible in many cases, and people were evidently living in the gardens and on verandas.

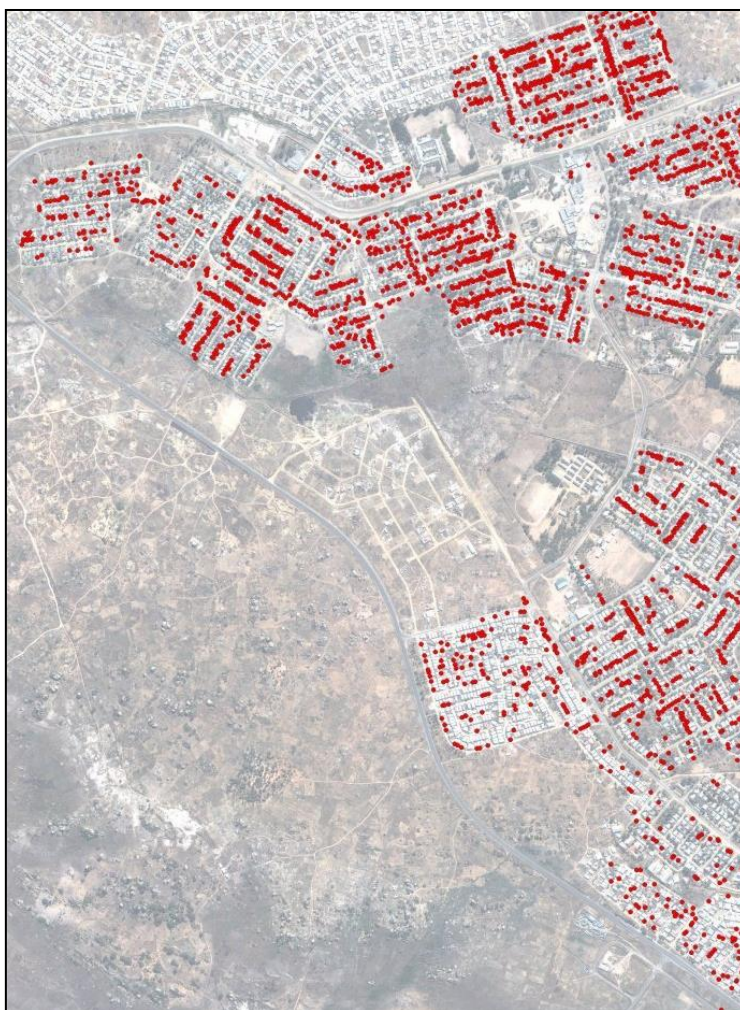
**Figure 10: Chitungwiza Structure Count**

Chitungwiza on 22 June 2005 with centre points of the 2470 removed structures.  
Images (C) COPYRIGHT 2006 DigitalGlobe, Inc. ALL RIGHTS RESERVED.

Analysis of the satellite images shows more than 2,000 backyard structures were removed in the portion of Chitungwiza captured by the satellite image. In addition, at least one marketplace in Chitungwiza was destroyed during the operation. In total, analysis of the satellite imagery indicates that 2470 structures were removed from this portion of Chitungwiza during Operation Murambatsvina. The size of structures themselves varied quite widely, with small backyard homes measuring 4 meters on a side and larger market structures measuring up to 40 square meters and more.

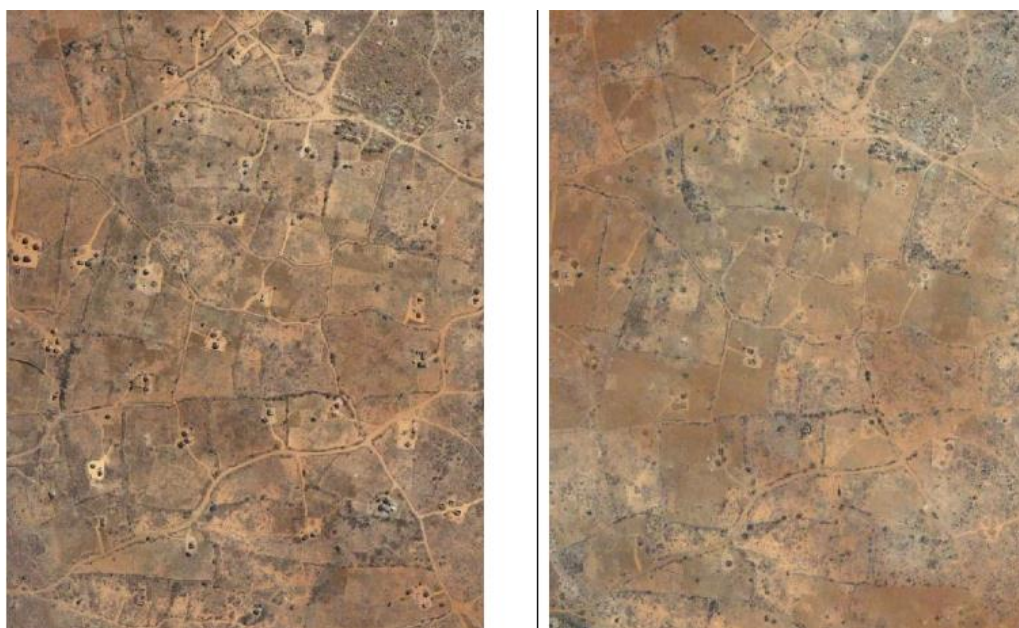
**Figure 11: Killarney Before and After Operation Murambatsvina**

A subset of the high resolution satellite imagery of the Killarney settlement in Zimbabwe. Note that the entire settlement of Killarney that was destroyed measured more than three kilometers from north to south and 1.6 kilometres east to west. Given the small size of the structures, they would not be visible were the full extent of the image shown. Some of the more than 465 Killarney structures are visible in the before (left hand) image, most of which are absent from the after (right hand) subset image. Images (C) COPYRIGHT 2006 DigitalGlobe, Inc. ALL RIGHTS RESERVED.

The informal settlement at Killarney, outside Bulawayo, was destroyed in June 2005 as part of Operation Murambatsvina. Two QuickBird images were obtained covering the area including a “before” image from 22 August 2004 and an “after” image from 7 September 2005.<sup>9</sup> The satellite imagery clearly shows the settlement in 2004 while the 2005 image shows most homes removed.

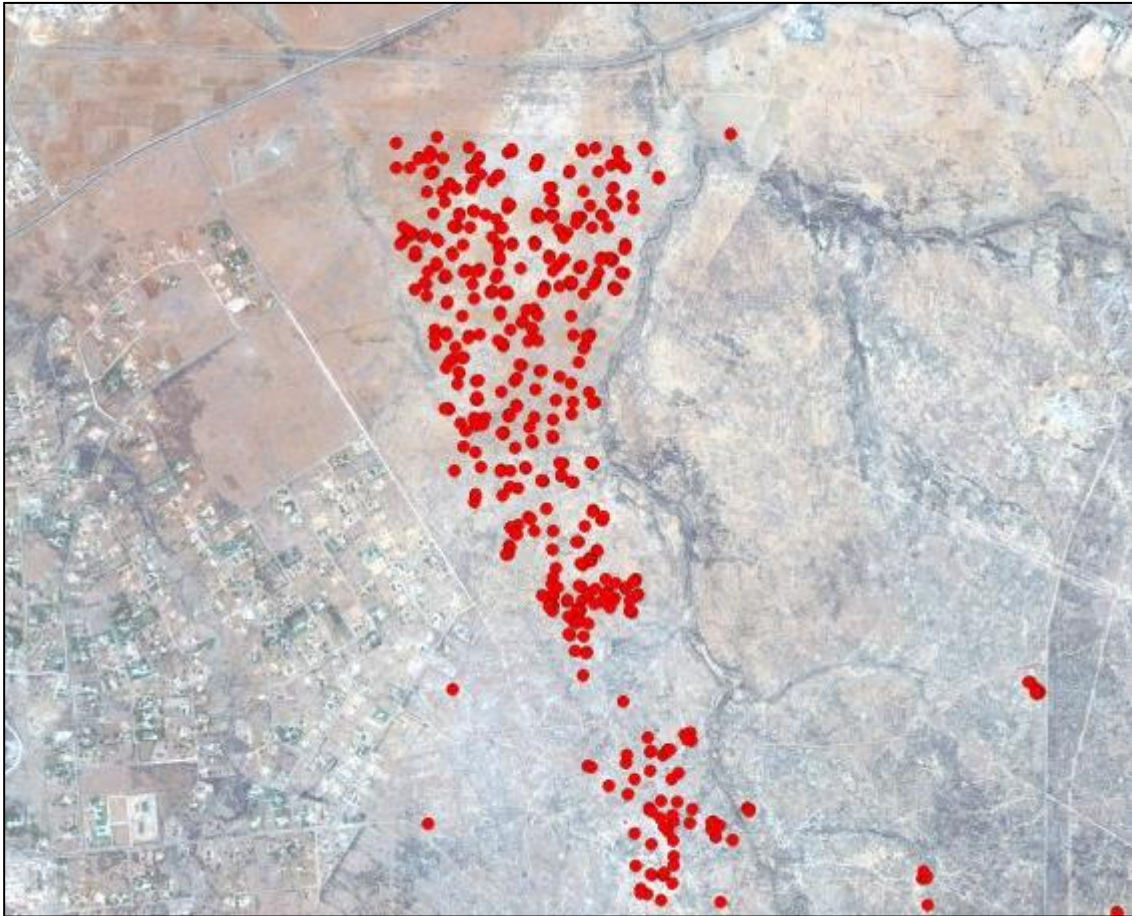
**Figure 12: Killarney Structure Count**

The informal settlement of Killarney (removed structures too small to be seen at this resolution). Centre points of the 486 removed structures.

A total of 486 structures were counted in the primary area of removal. The sizes of the structures themselves were generally quite small, measuring four meters on a side and smaller. One household many have comprised several small buildings.
